Underwater Vehicle for Detecting Ship Hull Damage

Abstract: - Proposed system for underwater vehicle hull inspection utilizes the camera technology to identify structural damages and sea growths on ship hulls. Equipped with precise imaging, the vehicle autonomously detects and locates areas of concern, transmitting the exact coordinates to authorized devices in real time. This approach eliminates the need for human divers to physically examine the hull, enhancing safety and efficiency, regardless of time and anywhere while voyage or sailing. The vehicle operates through a stable Ethernet power source, ensuring consistent communication and energy supply. By minimizing human intervention, this system aims to streamline underwater inspections, improving maintenance processes and reducing operational risks and cost.

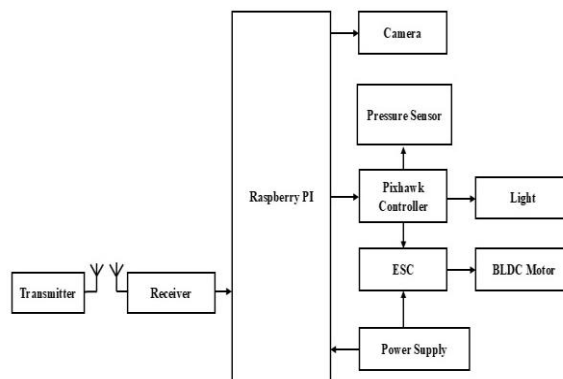
Fig 3. Block Diagram of Vehicle
